# Accident Investigation Reports Public Meeting August 31, 2004

**Sodium Release at the  
East Tennessee Technology Park**  
*Accident Investigation Reports Public Meeting  
August 31, 2004*

- The Board concluded that the direct cause of the incident was:
  - The sodium component failed due to over pressurization, and
  - The secondary containment (“Hot Box”) failed to contain the resultant sodium release allowing the sodium to come in contact with the environment
- The Board concluded there were inadequacies in DOE line management in the following areas:
  - Lack of Clarity in Roles, Responsibilities, and Authorities of Participants
  - Insufficient Safety and Health Oversight of the Sublessee’s Operations
  - Failure to follow the intent of the Secretary’s Moratorium on Recycling Metals

# **Strontium-90 Incident**

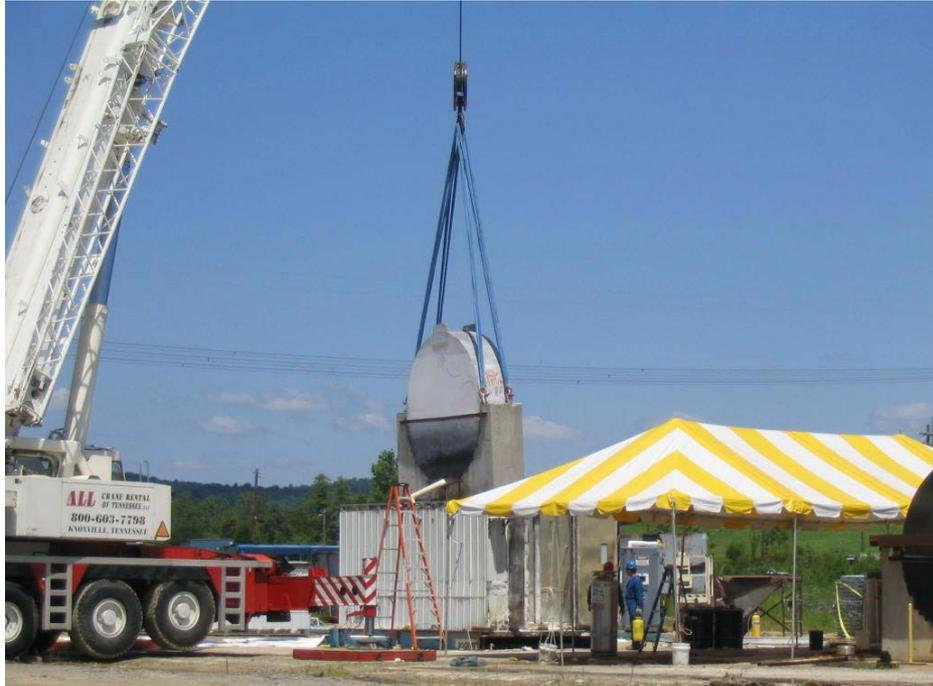
- Toxco teamed with Commodore Advanced Sciences Inc. to remove the sodium from several large components (11 feet in diameter) on its leased property.
- The first component was placed in a containment structure or “Hot Box” designed to heat the sodium to a liquid state so that it could be transferred to a suitable DOT-approved shipping container.

**Sodium-filled Component and Lower Half of the Containment Structure or “Hot Box”**

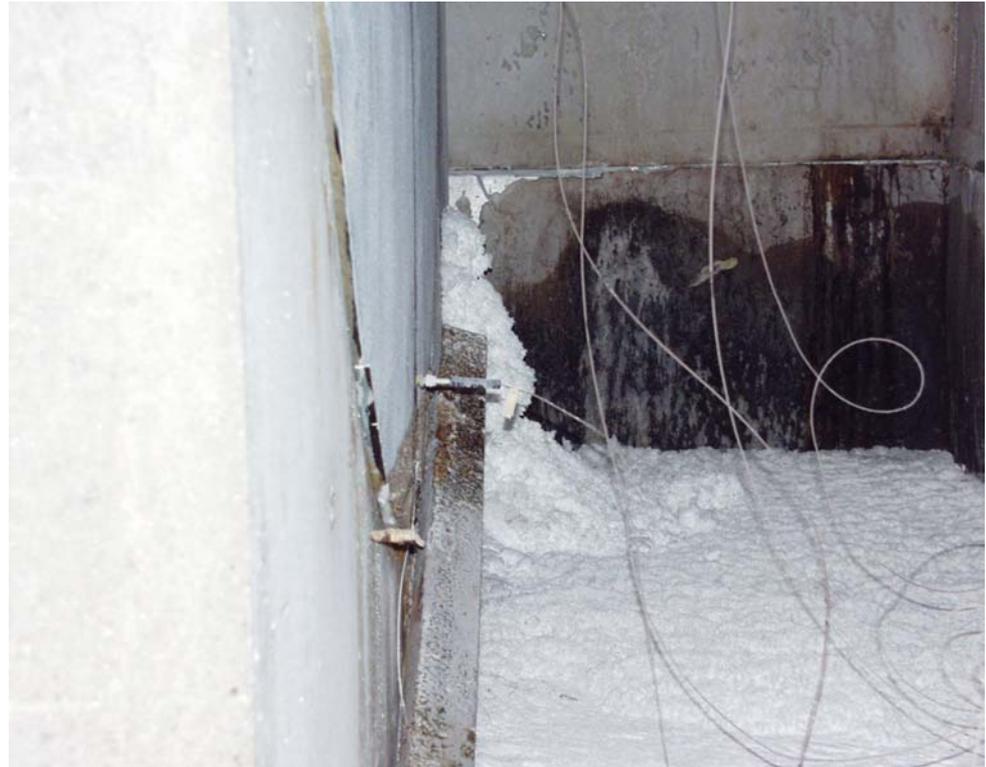
- On the morning of May 8, Commodore workers were heating the first component inside the containment structure when a rupture of the aluminum casing occurred, releasing an estimated 400 pounds of molten sodium onto the floor of the containment structure.
- A seal then failed on the containment door allowing a portion of the sodium to be released to the environment, initiating an exothermic reaction with moisture in the air and soil.

**The Point Where the Sodium Emerged  
From the Component Into the  
Containment Structure**

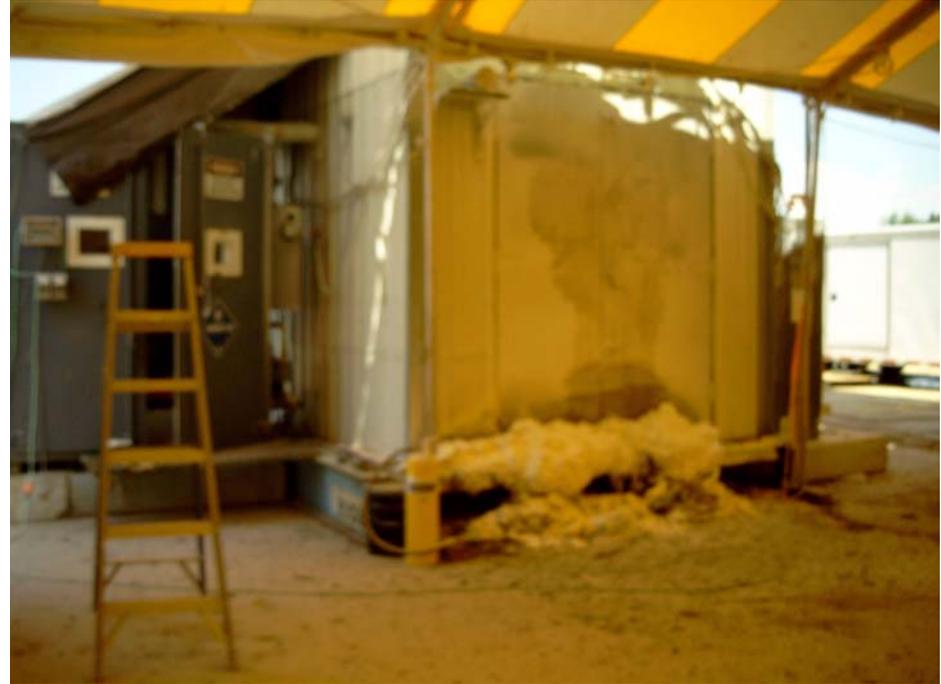
- Workers attempted to stem the flow by using Class D Met-LX Fire Extinguishers, the approved extinguisher for sodium fires, but this did not halt the release.
- With the sodium's exposure to the air and standing water on the surface of the ground, reaction products of sodium hydroxide, sodium peroxide, and sodium dioxide began to form and drift away from the immediate area.

**Aftermath of Sodium Release  
Showing Reaction Products on the  
Sill of Hot Box**

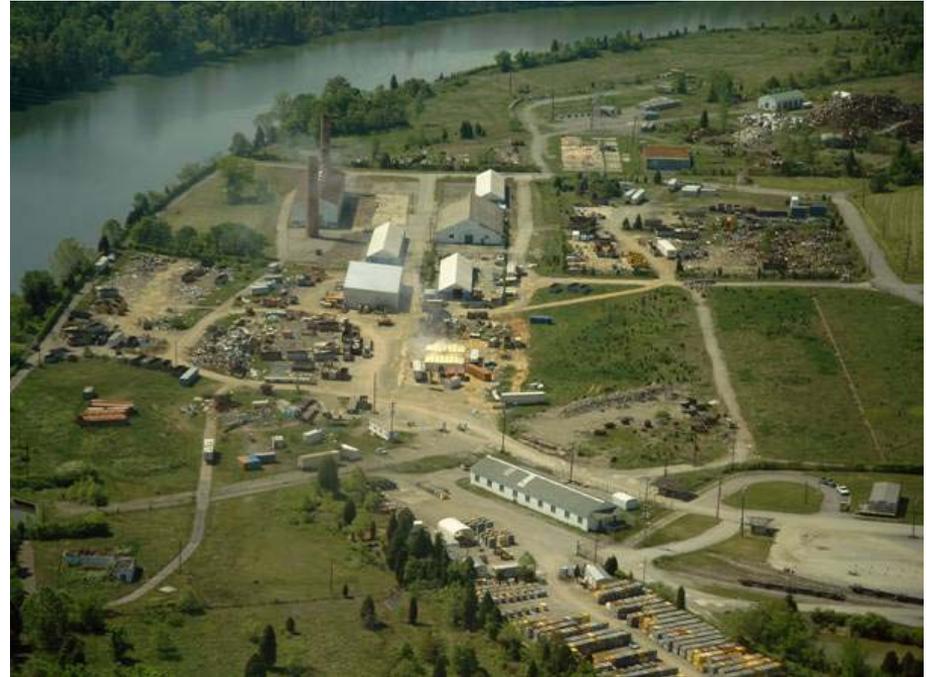
- These hazardous reaction products are severe irritants and effects of inhaling or swallowing them can range from mild irritation to serious damage of the upper respiratory tract, mouth, throat or stomach, depending on the severity of the exposure.
- This plume of hazardous residues and inability to predict when the reaction would subside led to the Tennessee Emergency Management Agency's recommendation for a temporary closure of the Clinch River and Highway 58, and evacuation of residents within a half-mile radius.

**Aerial Photo of Site Taken in Early Afternoon on the Day of the Release**

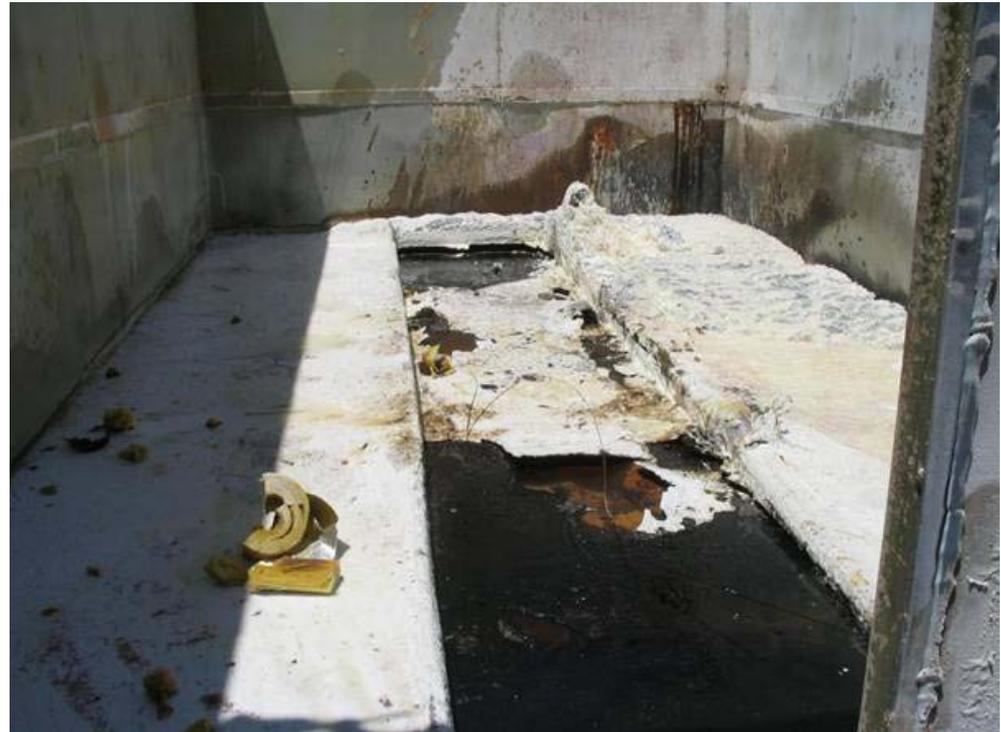
**Reacted Sodium on Floor of the Hot Box Prior to Removal**

- Recovery activities were initiated the following day, May 9.
- The top half of the “Hot Box” has been removed, the failed component has been removed from the “Hot Box,” and the reacted Sodium is being removed from the floor and containerized.

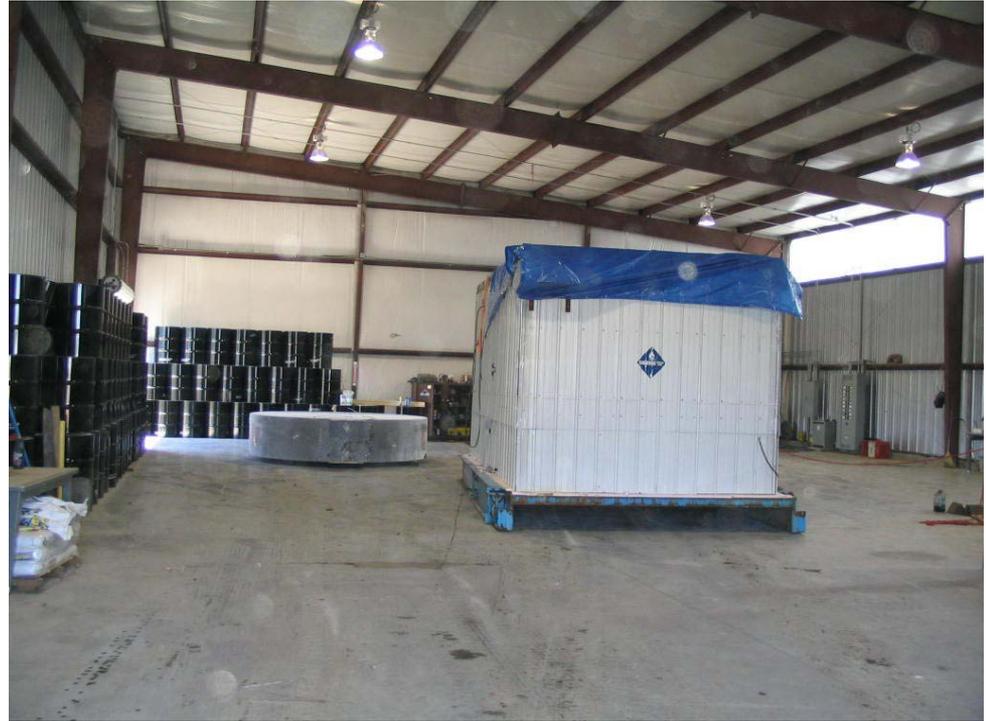
**Failed Component and Lower Half of  
Hot Box in Toxco Facility**

- After removal of the failed sodium component from the “Hot Box” structure, both it and the “Hot Box” were relocated to an adjacent Toxco building where they are now.
- It has not yet been decided what will be done with the remaining sodium components. The primary focus has been on the immediately necessary steps of recovery and stabilization.

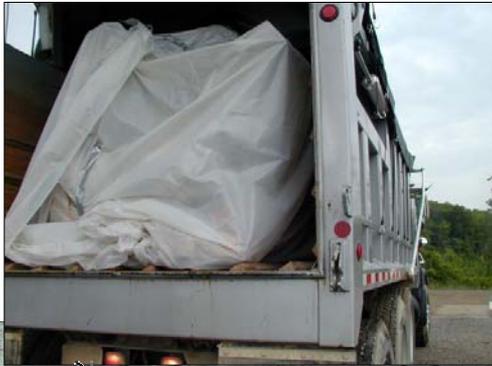
**T-12  
Shipment**

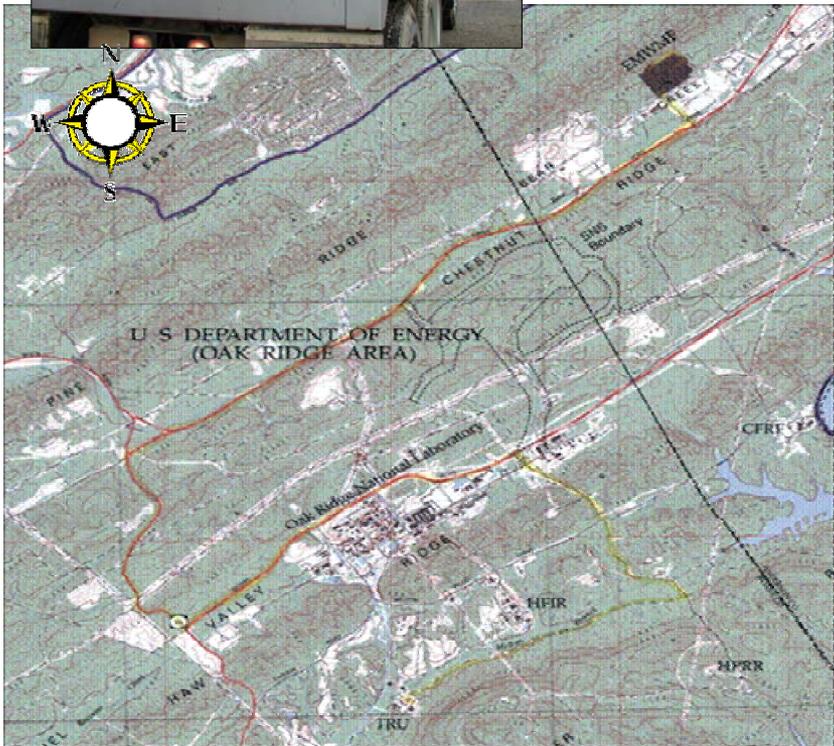
**Shipment Route**

- Truck left NHF at 11 a.m. and arrived at Onsite Disposal Facility at 11:30 a.m.
- Arrival survey detected contamination and Onsite Disposal Facility road shut down at 11:45 a.m.
- Notification to DOE-ORO personnel by 12:15 p.m.
- Contamination detected on Melton Valley Access Road at 1:20 p.m.
- TEMA closed portions of Highway 95 for radiological survey at 4:21 p.m.
- Radiological surveys initiated at 5:45 p.m.
- Bear Creek Road between ORO check point 20 and Highway 95 closed at 6:22 p.m.
- Work at NHF suspended

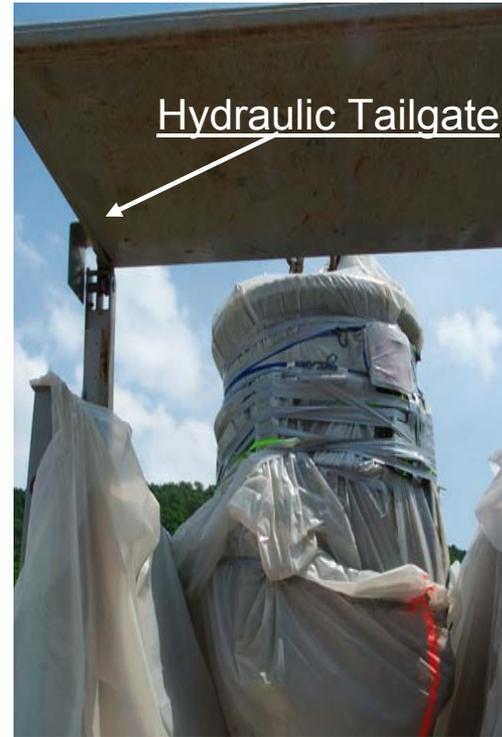
- **March 16** – 12 to 18 inches of liquid discovered in the tank
- **April 14** – Portland cement added to solidify liquid
- **April 20 – May 12** – Tank T-12 was stored for several weeks in adjacent facility without adequate weather protection
- **May 12** – Liquid discovered in tank wrapping while loading for transport
- **May 13** – Truck bed tilted in an effort to collect and remove any additional liquid
- **May 14** – Visual inspection performed and truck was cleared to go

**Tank T-12  
Being Placed  
Into a Truck  
Bed Lined With  
Plastic**

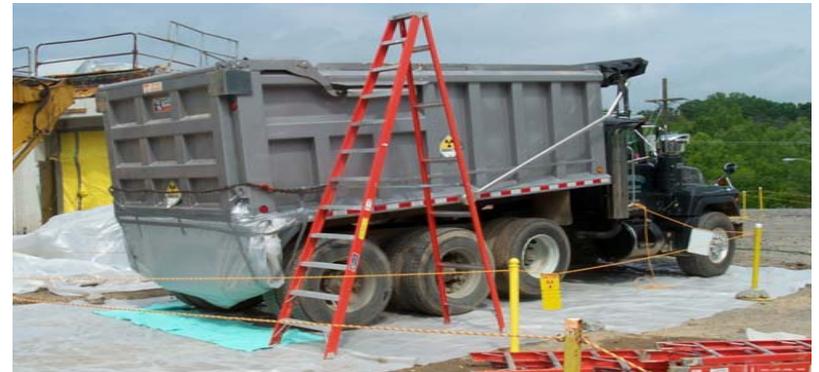
**Tilting the Truck Bed to  
Collect Any Additional Liquid**
